SEA LEVEL RISE VULNERABILITY ASSESSMENT

Pacifica, CA

Prepared for
The City of Pacifica

January 2018

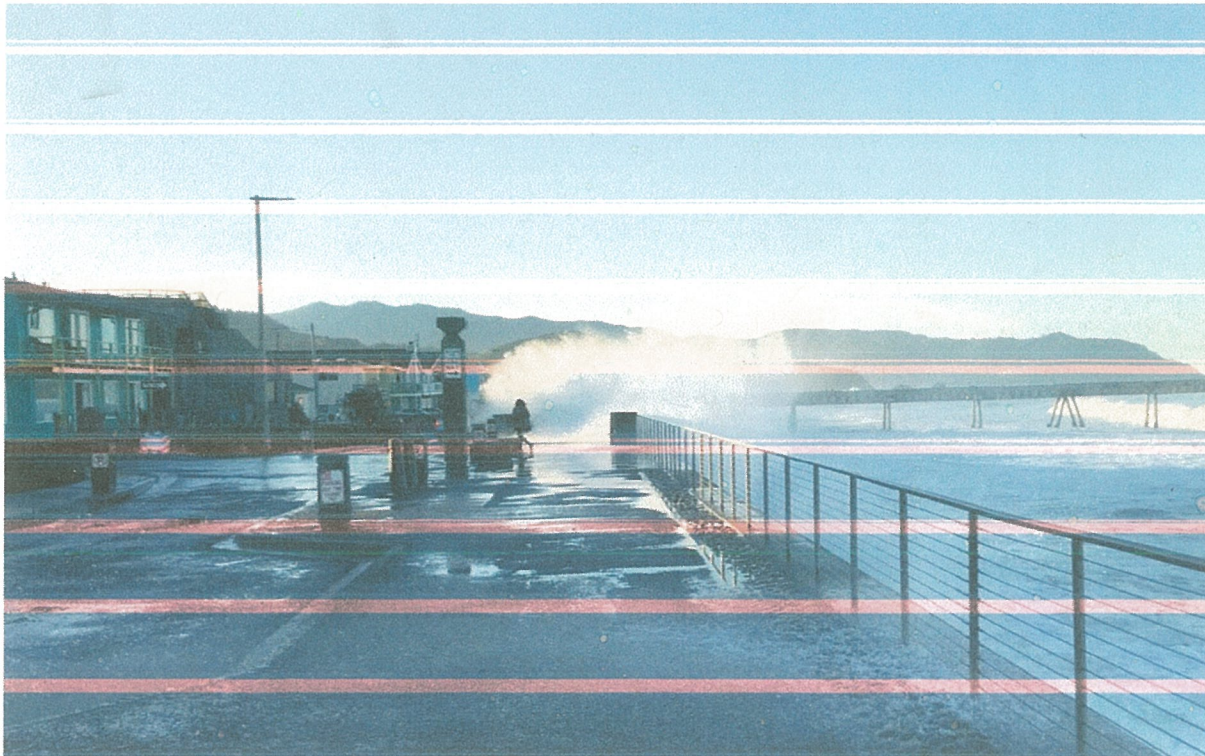
Near-king tides and high surf at Beach Boulevard on November 30, 2017 (J. Jackson)

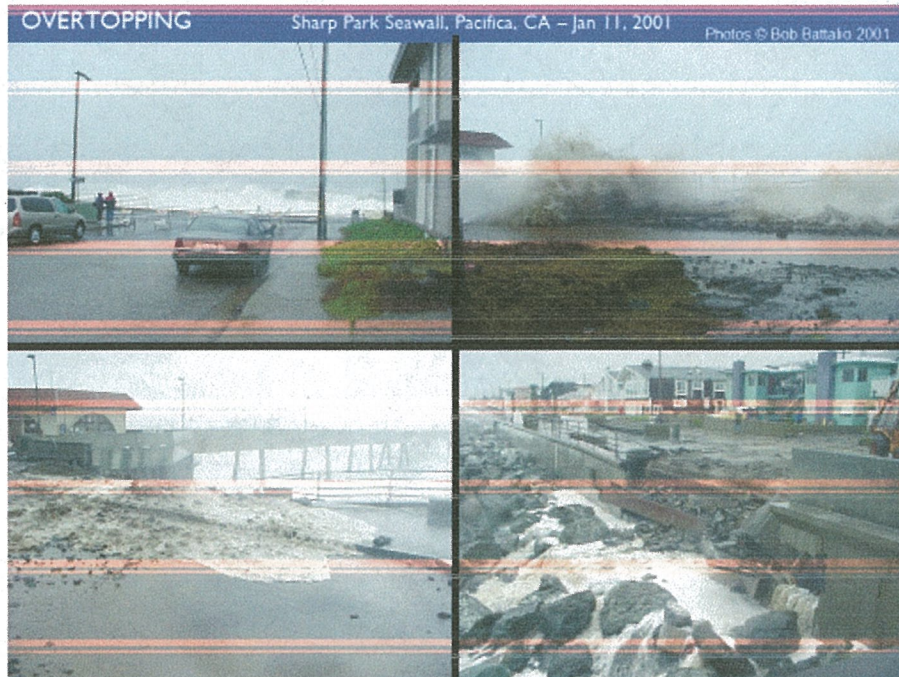
Figure 2
Observed flooding and erosion along Beach Blvd on January 11, 2001

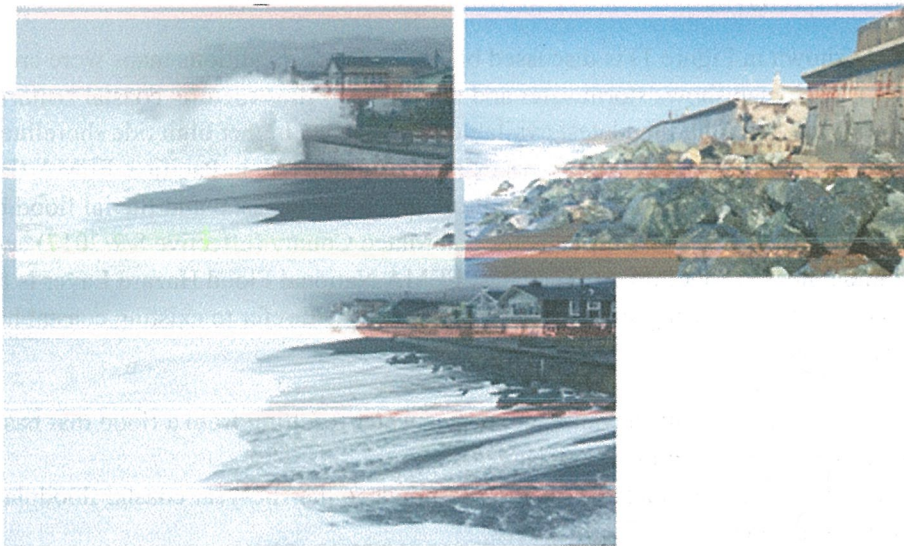
Figure 3
Observed flooding and erosion events at Pacifica on January 22, 2016

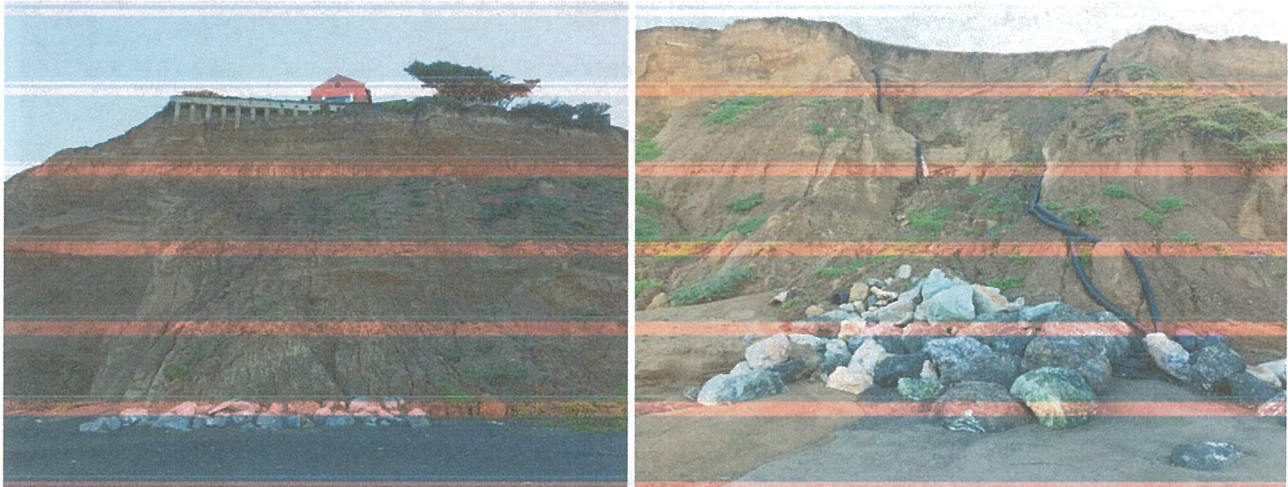
Figure 6
Dollaradio Station with rock at toe and Piles at top of bluff (Left)
Drainage pipes and terrestrial erosion of bluff south of Dollar Radio (Right)

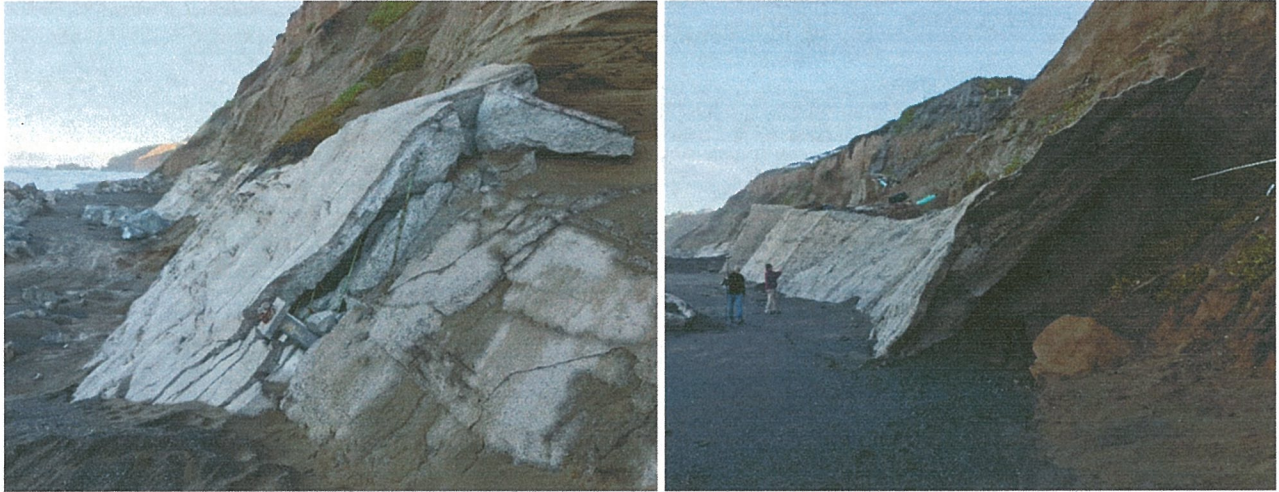
Failure of seawall caused by erosion behind structure and partial collapse

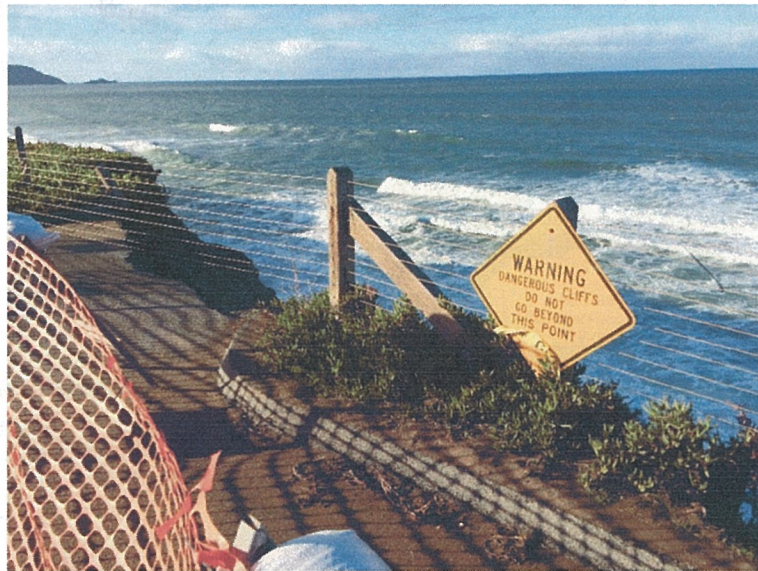
Figure 10
Bluff top trail at Esplanade Ave at risk of erosion (photograph Dec 20 2017)

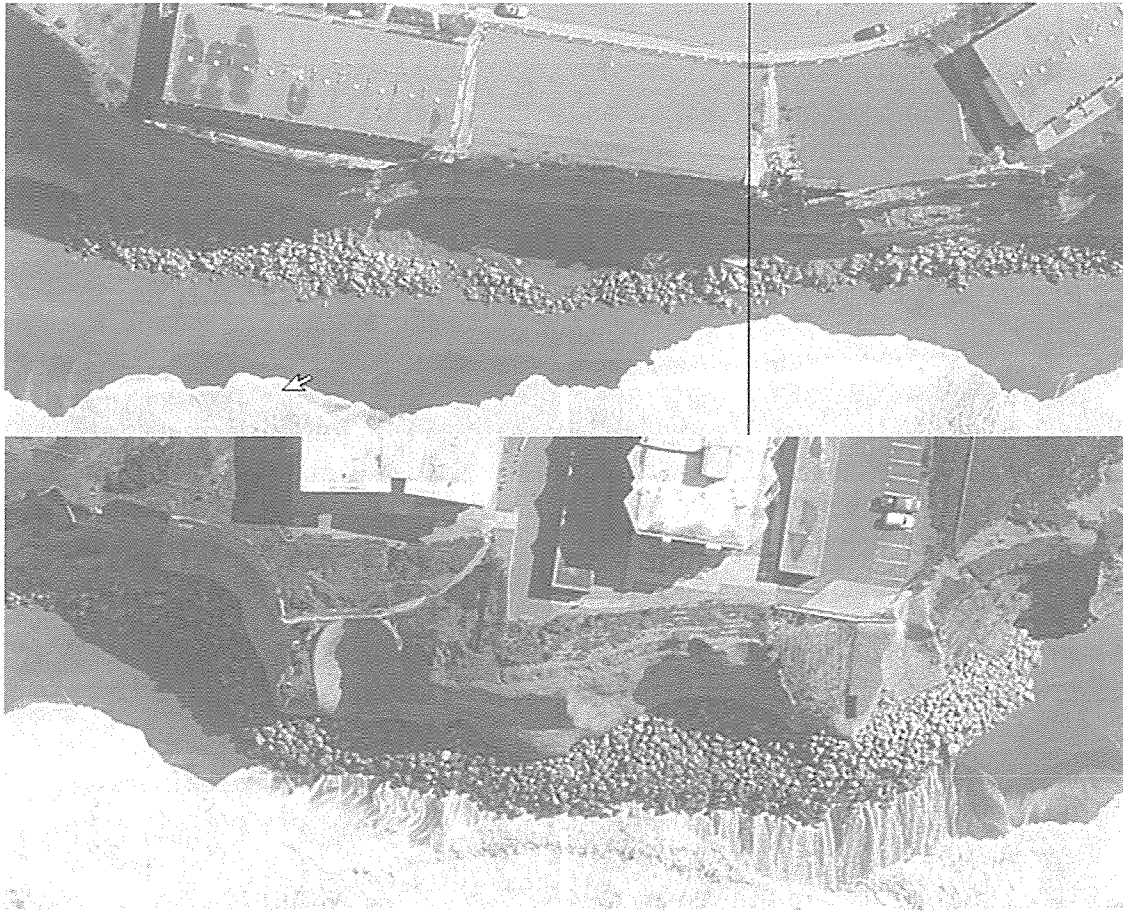
Figure 11
Bluff toe armoring and erosion at Esplanade blufftop apartments (top)
Bluff toe and face armoring at The Bluffs apartments (bottom)

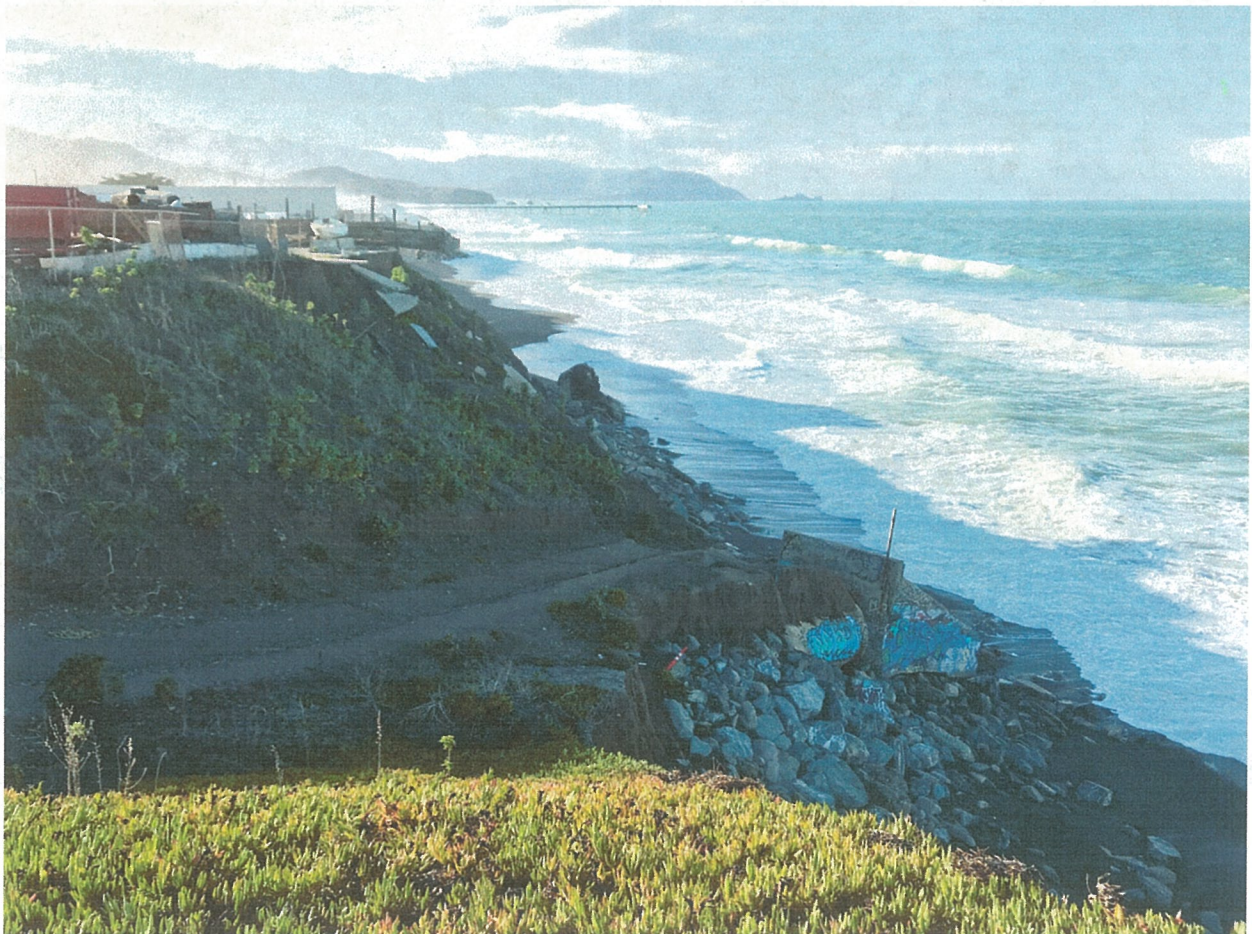
Figure 13
 Damaged stormwater outfall in foreground, landfill and eroded rubble on narrow beach beyond
